MEDICAL EFFECTS OF ATOMIC BOMBS

The Report of the Joint Commission for  
the Investigation of the Effects of the  
Atomic Bomb in Japan; Volume VI

July 6, 1951

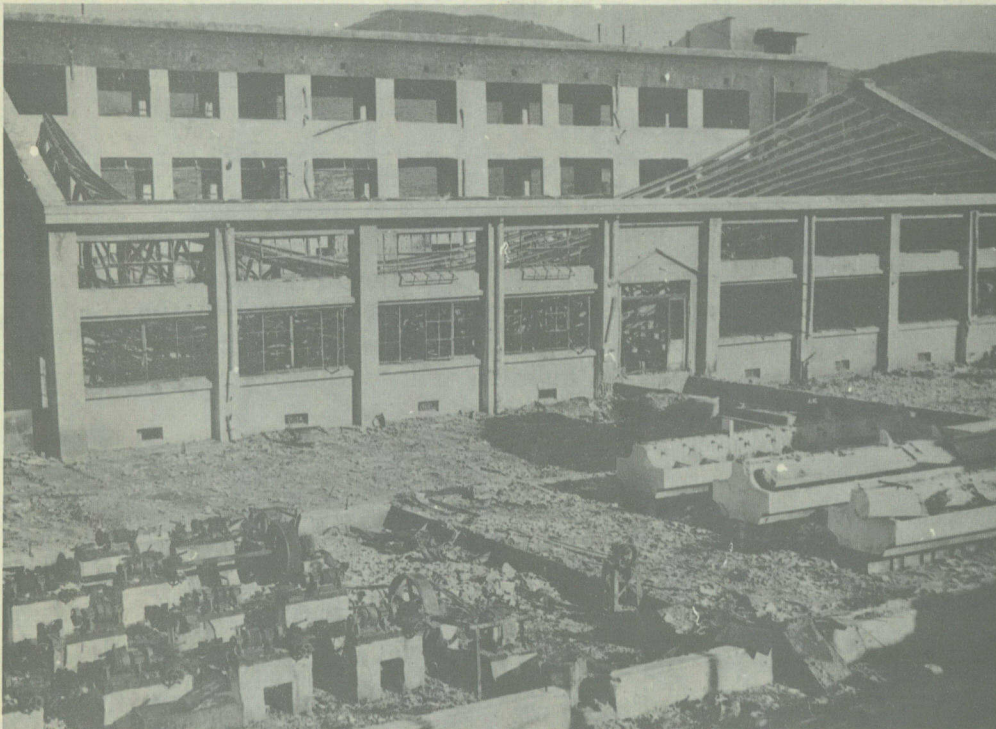
Figure 3--(11N). Fuchi School, 1000 meters. Scene is the courtyard showing the machine shops, and the caved in roof of a light steel and concrete shop. Fire has destroyed all the blasted structures. (Photo File # NB 317.)

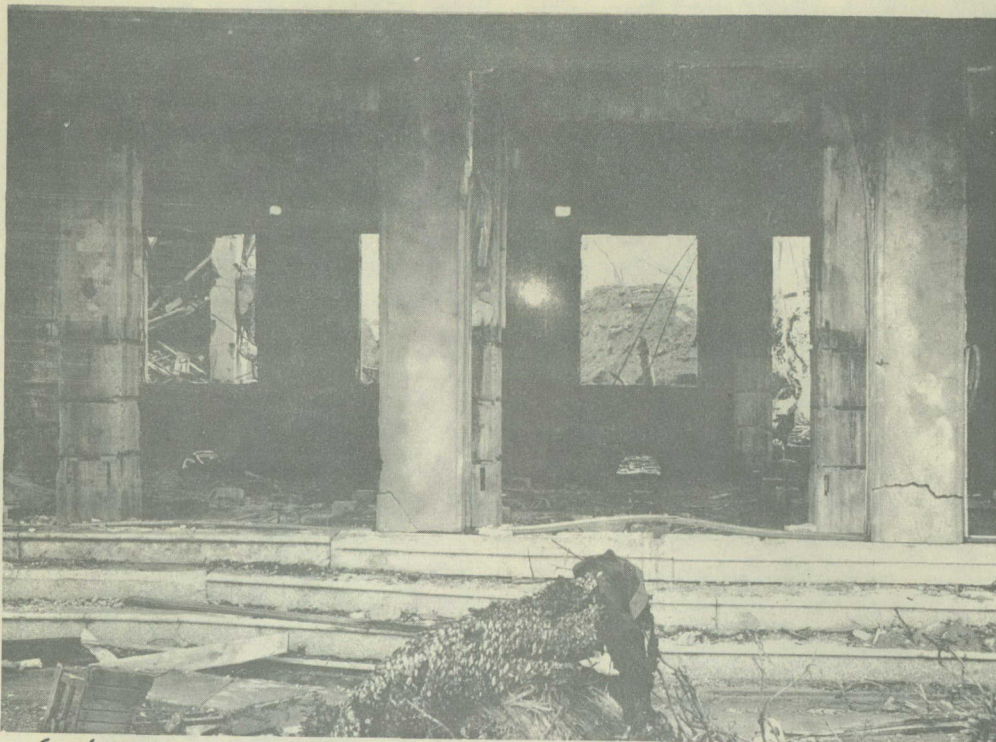
Figure 6--(11N). Shiroyama National School. View of the main entrance. Notice the depression of the stone steps due to blast. (Photo File # NB 323.)

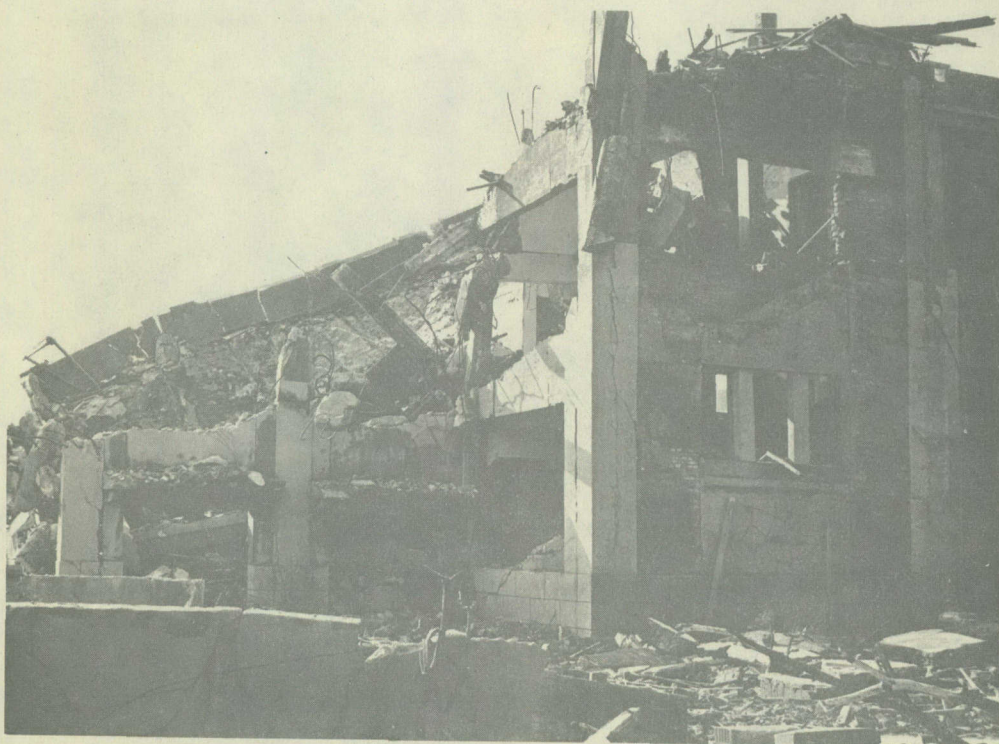
Figure 7--(11N). Shiroyama National School, 500 meters. Close-up view of the South wing showing the collapse of the roof and the 3rd floor. (Photo File # NB 308.)

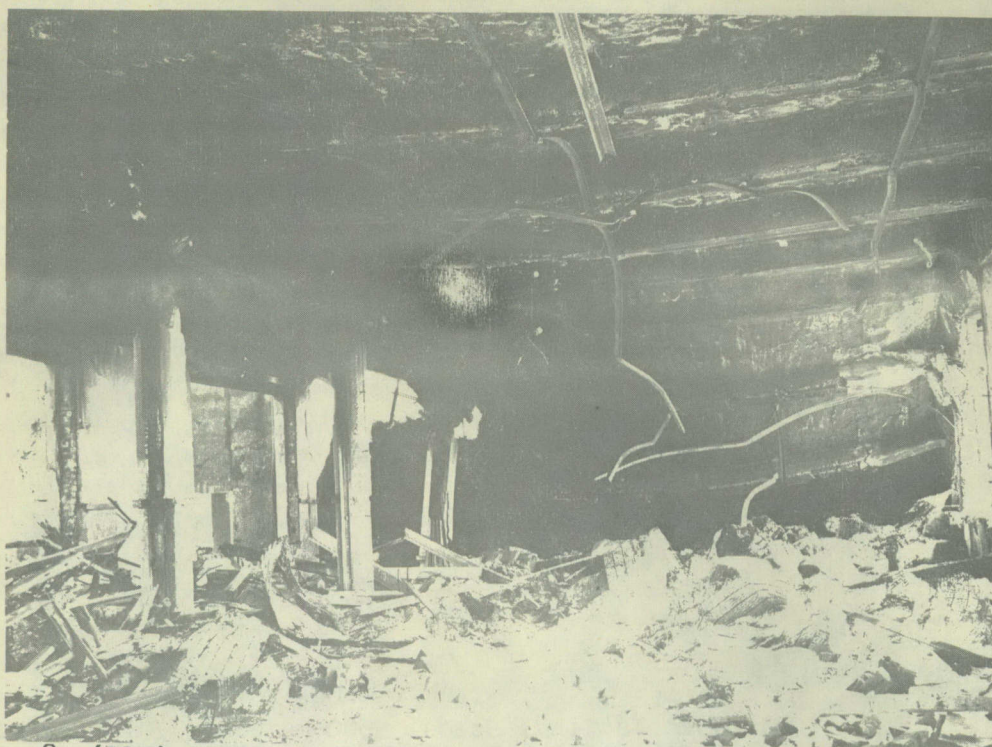
Figure 8--(11N). Shiroyama National School, 500 meters. Interior view, 3rd floor of the south wing, showing the collapsed roof. There were no survivors among the 66 people who were on the 3rd floor. (Photo File # NB 315.)

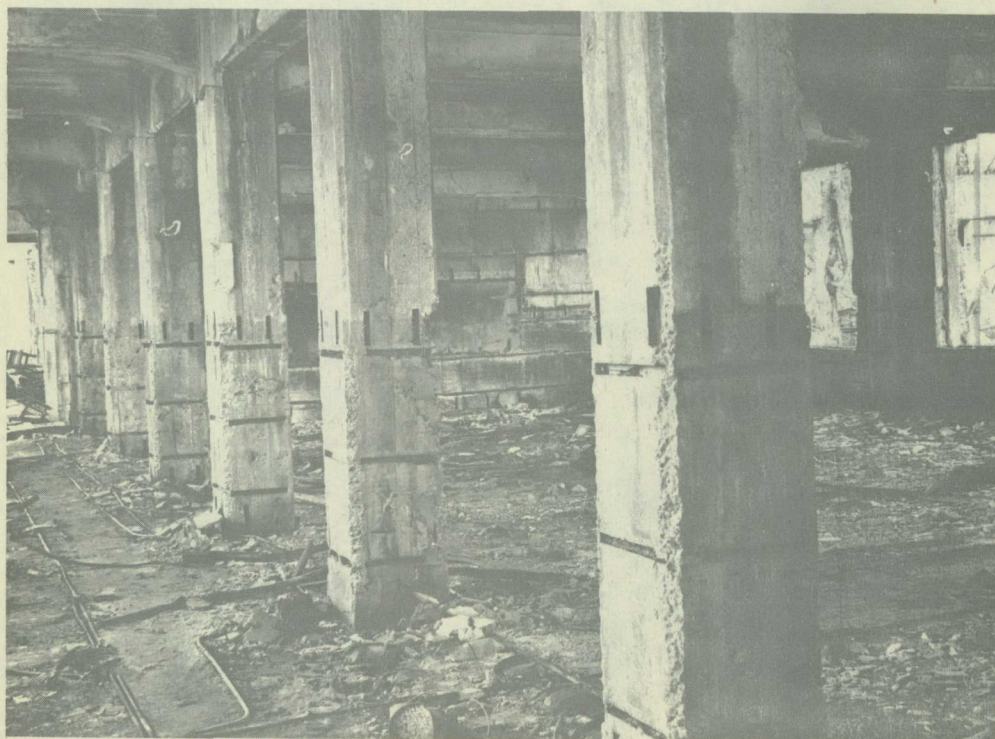
Figure 9--(11N). Shiroyama National School, 500 meters. Interior view of second floor, west wing. There was only one survivor of the 7 people in this room. (Photo File # NB 312.)

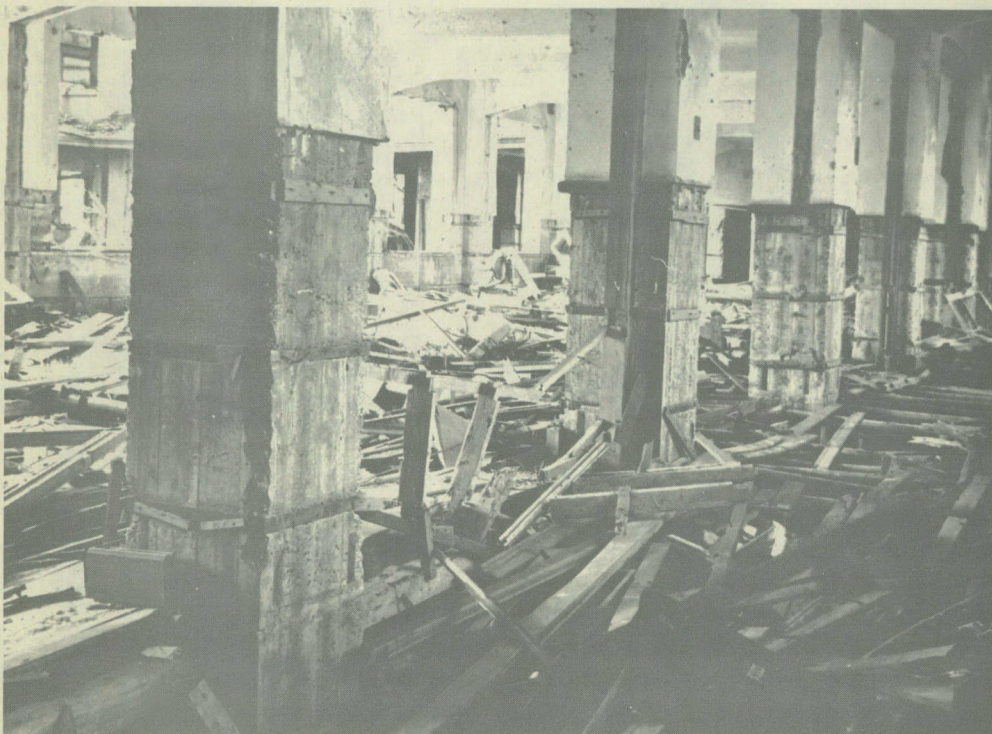
Figure 11--(11N). Shiroyama National School, 500 meters. Interior view, 1st floor, north wing. Notice the shattered remains of the wainscoting and interior trim. This did not burn. One person of 7 survived in this room. (Photo File # NB 309.)

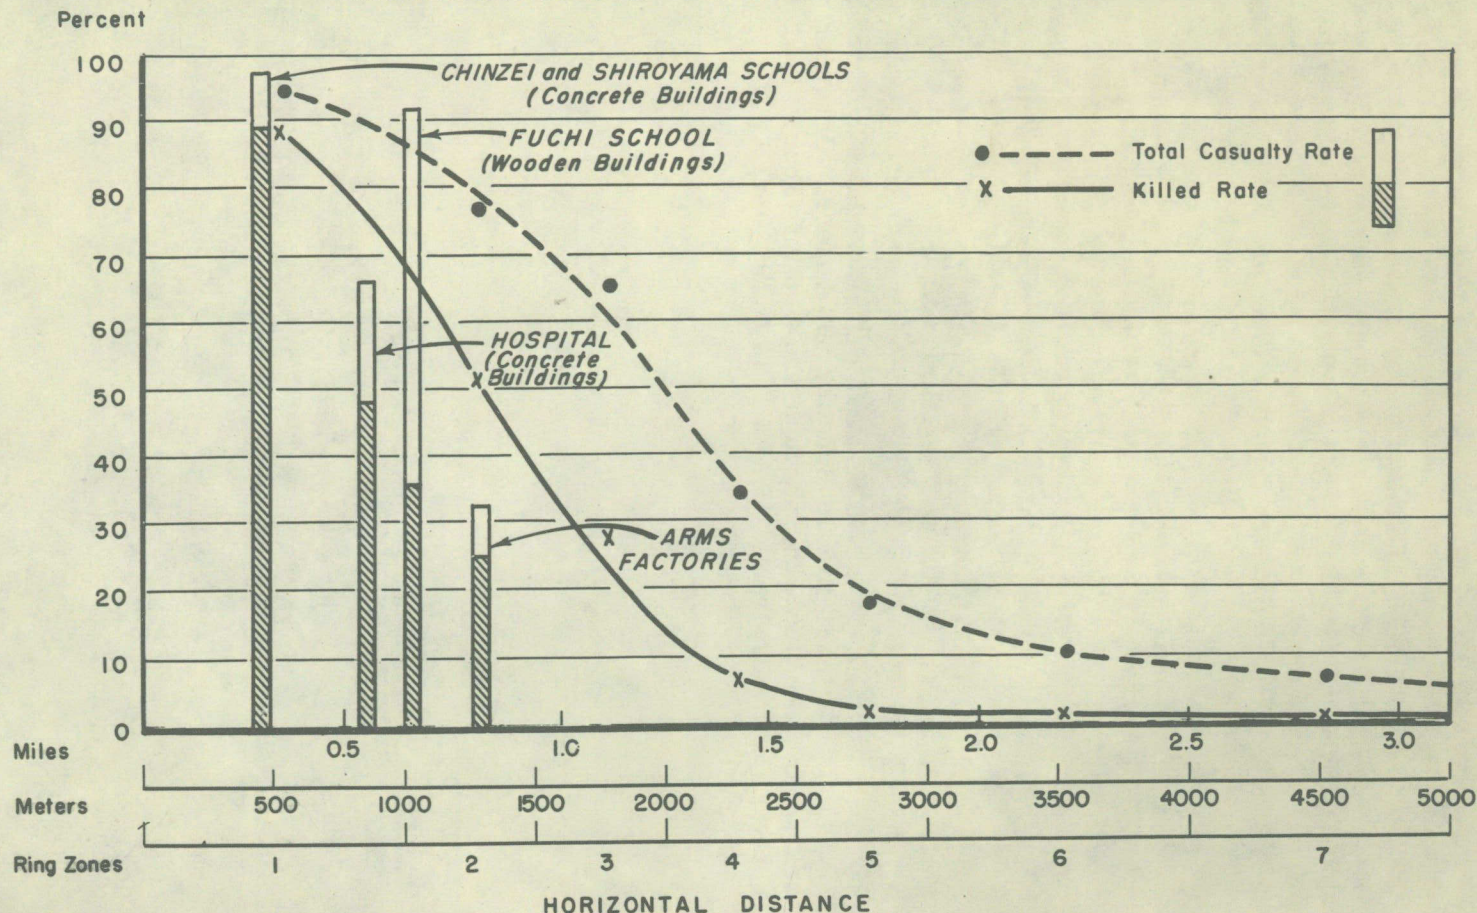
Figure 12--(11N). Smoothed curves for killed rate and total casualty rate, shown in relation to similar rates for specific buildings. (Photo File # NP 166b.)

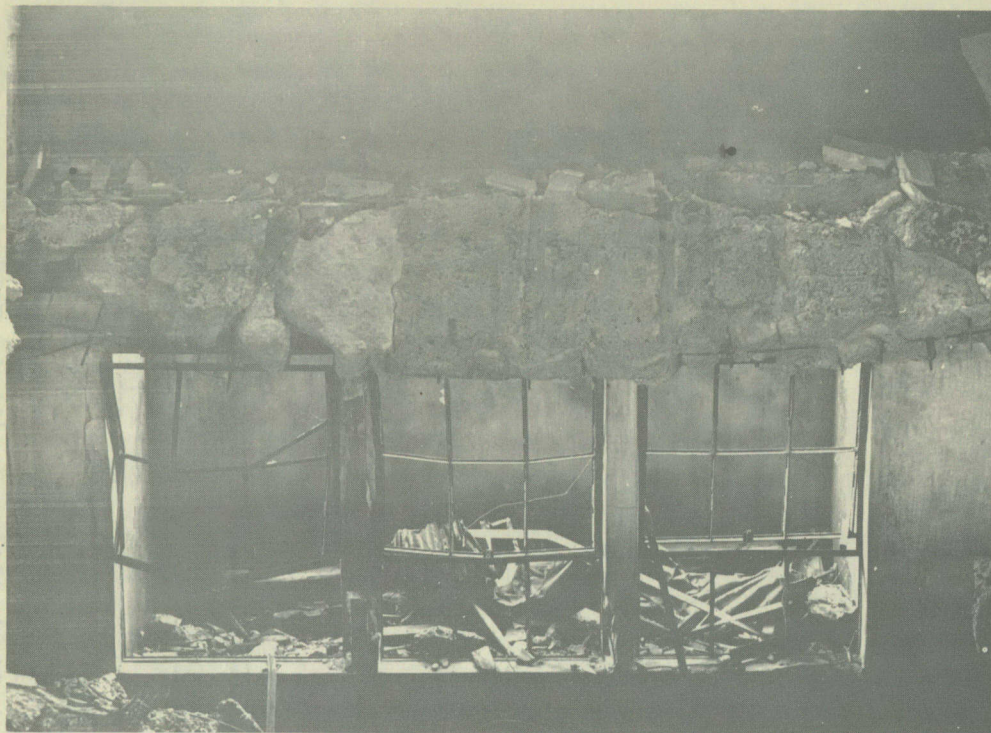
Figure 13--(11N). Chinzei Middle School, 500 meters. Interior view, 1st floor, looking into the cellar, through the broken floor. Four of the 5 people in the cellar survived. (Photo File # NB 303.)

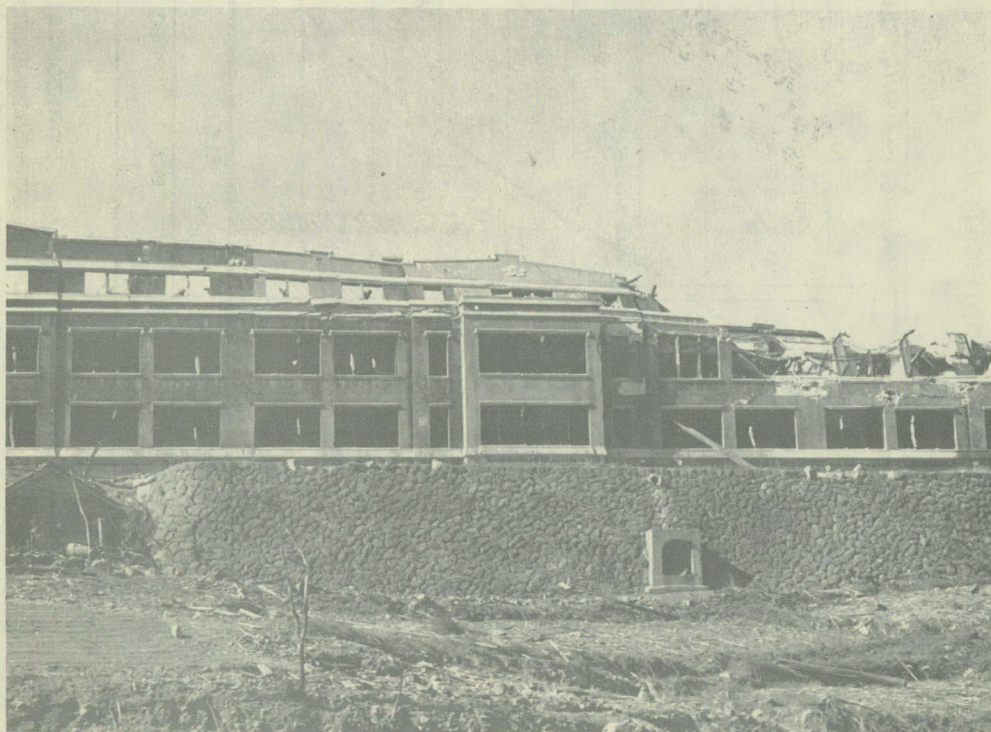
Figure 14--(11N). Chinzei Middle School, 500 meters. Exterior view of the front of the school, facing east, showing the damage to the roof and the upper two floors. See also Figure 17a,b (3N). (Photo File # NB 409b.)

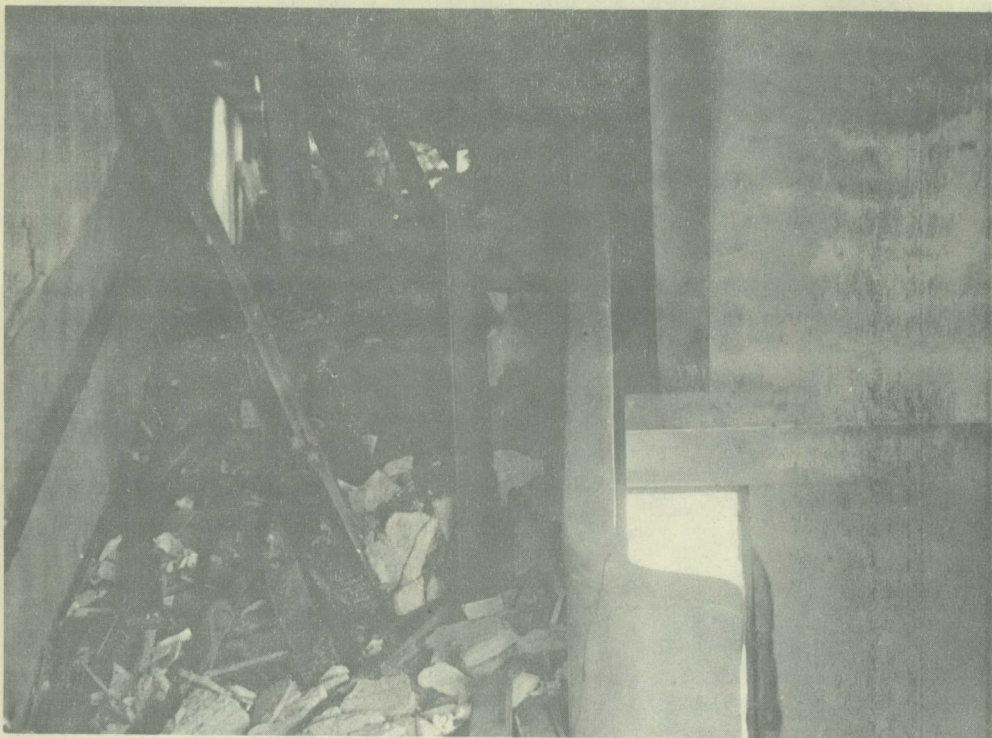
Figure 15--(11N). Chinzei Middle School, 500 meters. Interior view, 4th floor, showing the depression of the roof. There were no survivors on this floor. (Photo File # NB 307.)

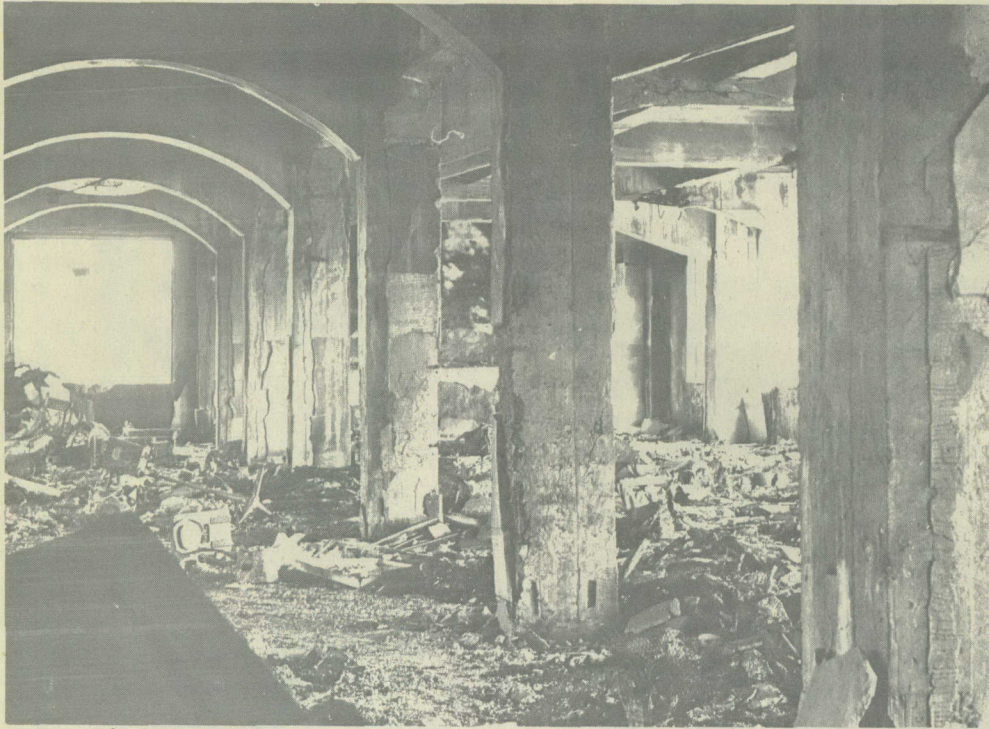
Figure 17--(11N). Chinzei Middle School, 500 meters. Interior view, 2nd floor. Notice the heavy construction and the evidence of fire damage to the wooden structures which were stripped from the walls by the blast. All 36 persons in this section of the 2nd floor died. (Photo File # NB 305.)

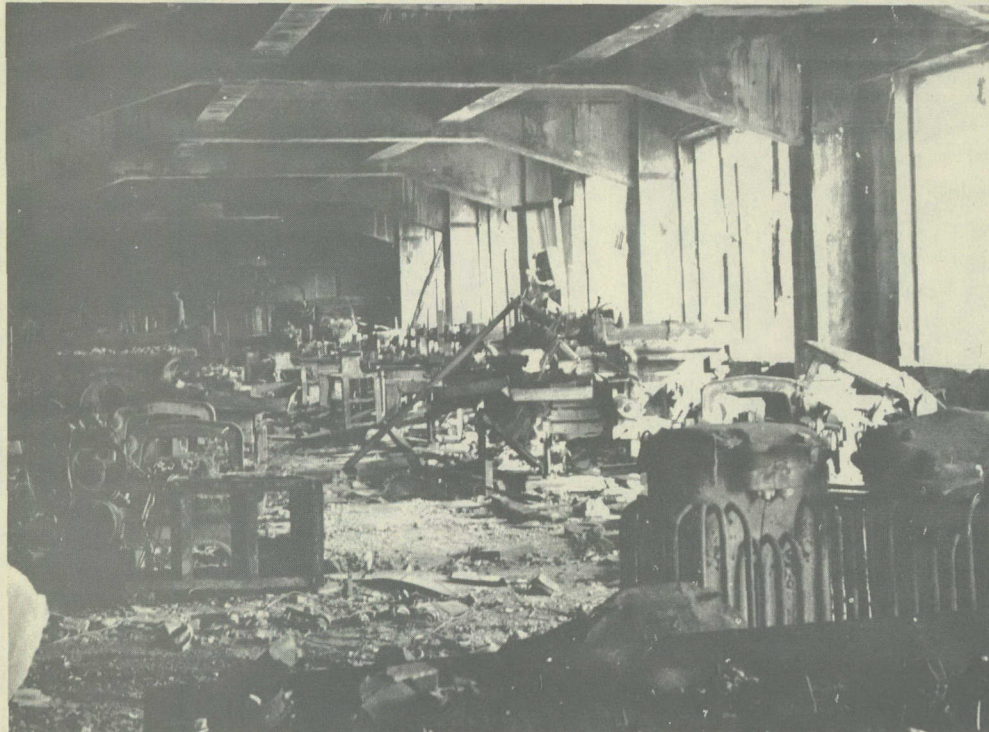
Figure 18--(11N). Chinzei Middle School, 500 meters. Interior view, 1st floor, showing a room used as a shop. There were 2 survivors among the 13 people in this room. (Photo File # NB 302.)

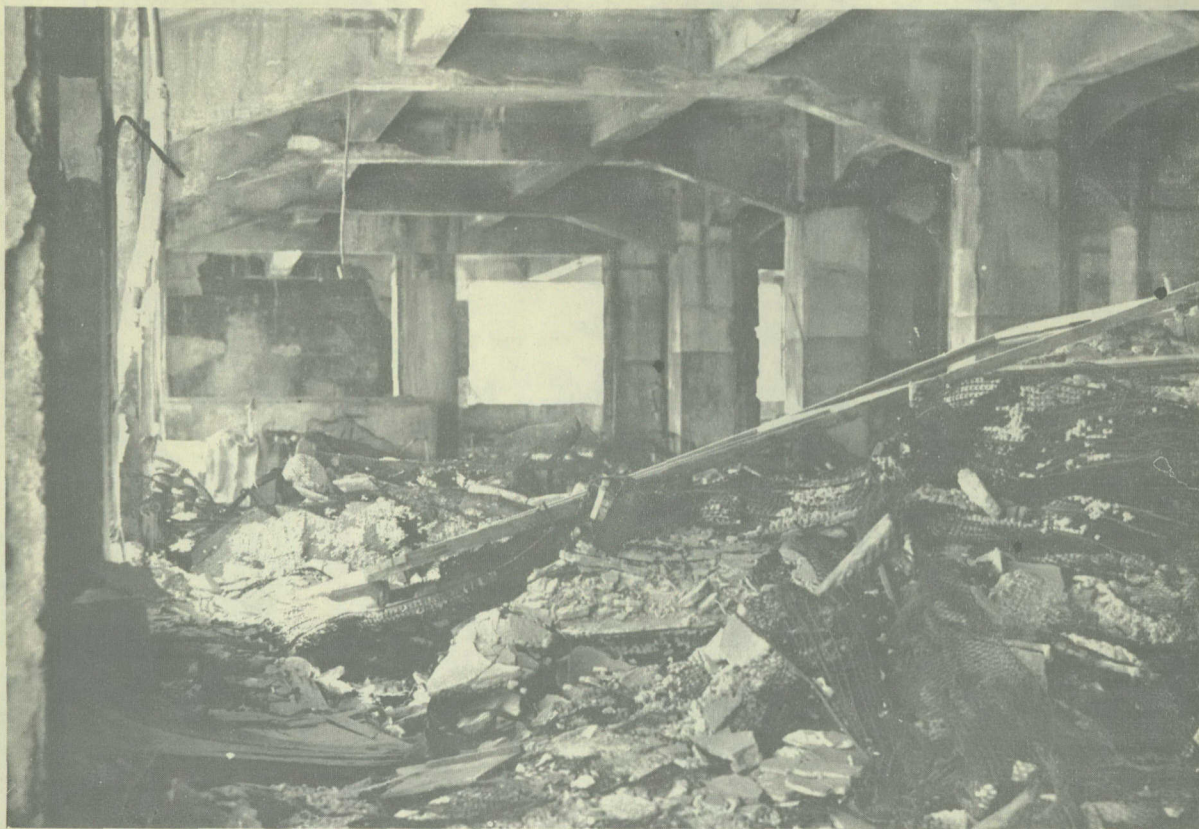
Figure 19--(11N). Chinzei Middle School, 500 meters. Interior view, 1st floor, south wing. Notice the debris that has been stripped from the walls. There were no people in this room at the time of the blast. (Photo File # NB 301.)

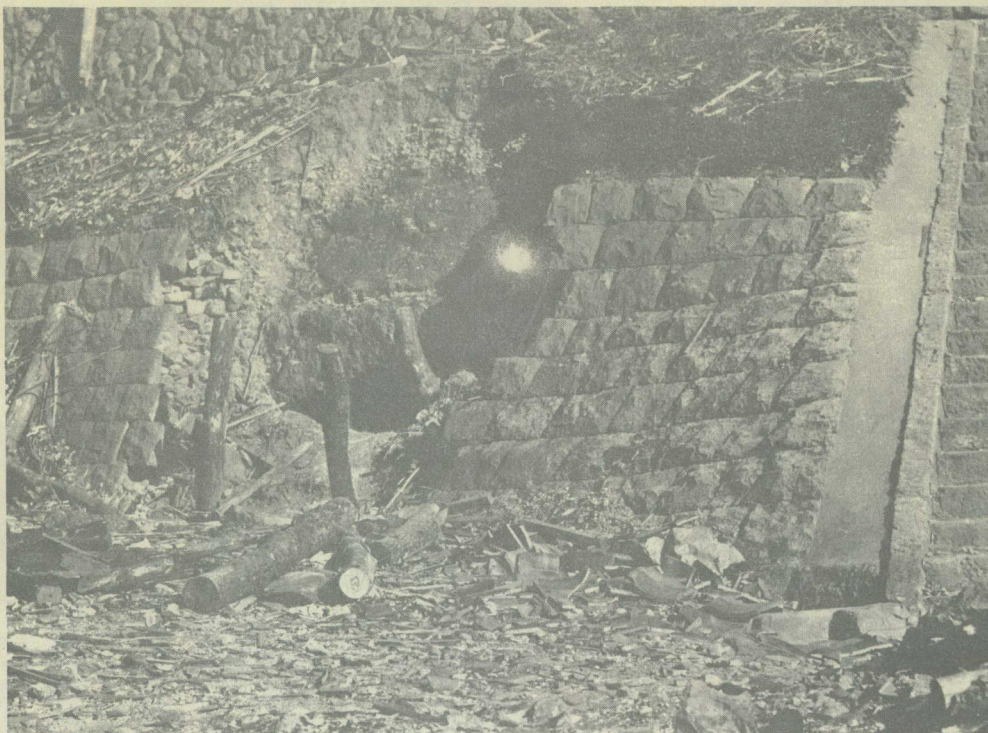
Figure 24--(11N). Exterior view of a cave in Okamachi (Cave # 1), 200 meters north of the center. People well inside the cave survived; those at the entrance were instantly burned to death. (Photo File # NB 328 A.)

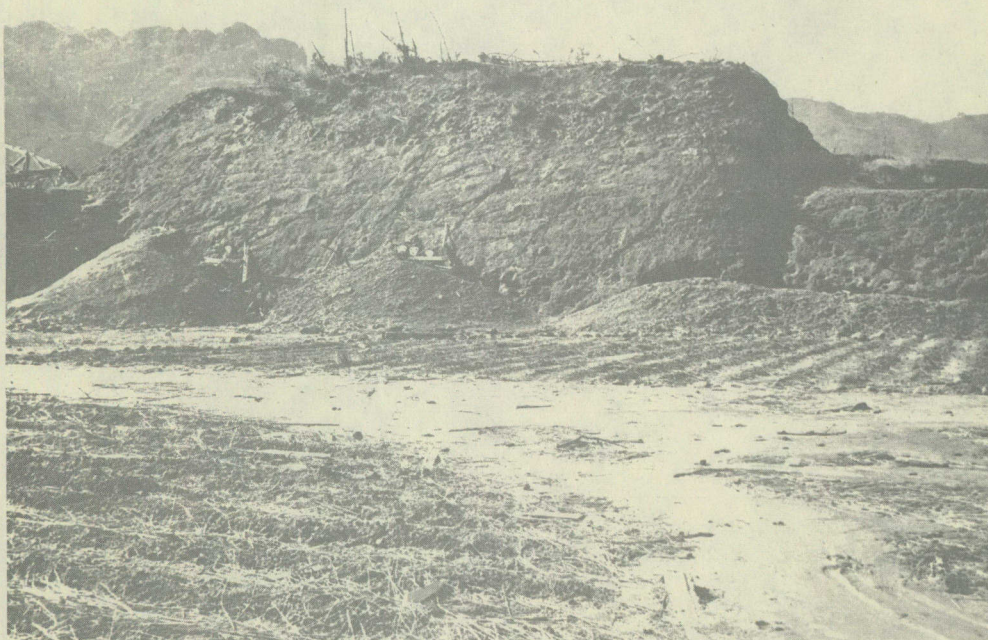
Figure 25--(11N). Shiroyama National School, 500 meters. Cave shelter behind the school. The three entrances are partially concealed by mounds of earth which act as barriers. People who were inside the cave and were not burned survived. (Photo File # NB 329.)
